Basic Utility Vehicle: 2008 Design Upgrades

Lindsay Emerson

April 23, 2007

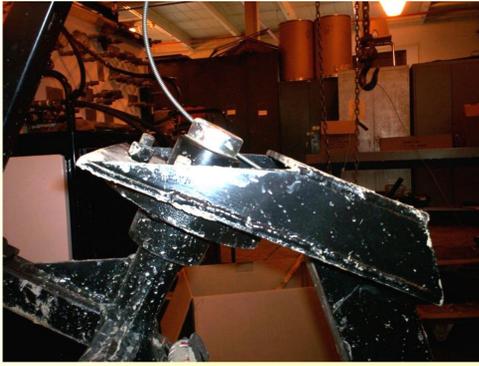
Original Design:

- Front plate
 - Flexed to stretch.
 - Deformed in multiple locations.
- Could not withstand a combination of vertical and lateral forces.
- The 1/4" plate was not strong enough.

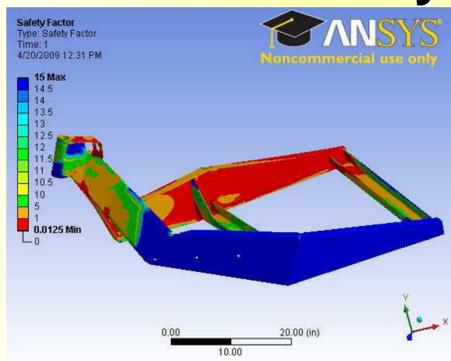
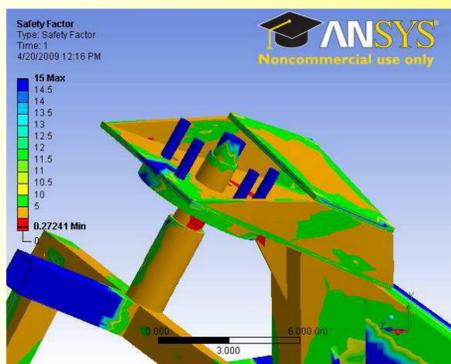
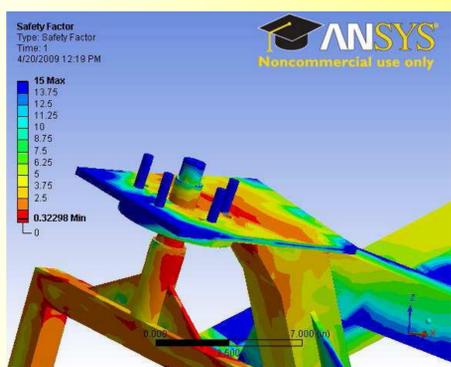
Finite Element Analysis on Design Iterations:

- Prototype front frame in computer testing proved it could not withstand its designed purpose.
 - 1.5g vertical impact
- Single gusset with box was not long enough to provide support to the plate when tested at 1/4".
 - 3g 45° impact
- Pipe reinforcement was not long enough to provide proper support. This was also tested with a 3/8" plate.
 - 3g 45° impact

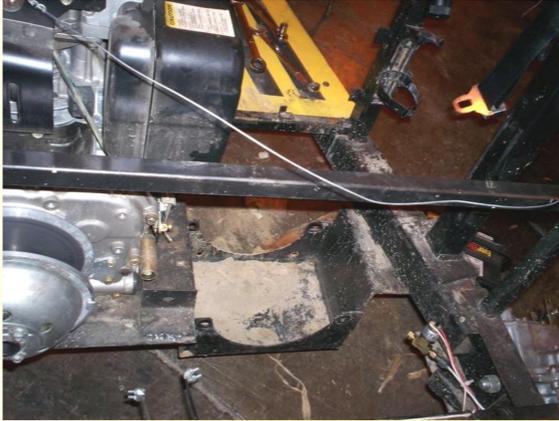
Original Design:

- Empty space shown used to hold the transmission.
- Transmission hung 4 inches below frame rails.
- Created clearance problems for the vehicle on uneven terrain.

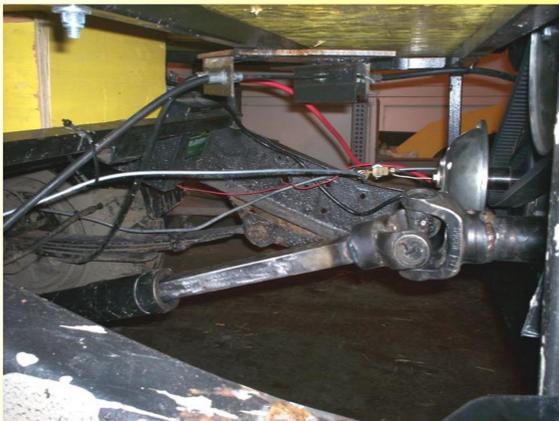
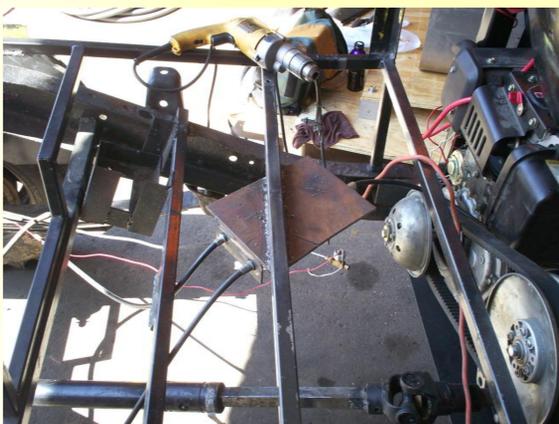
Unforeseen Problems:

- Angle on the drive shaft became too steep. Thus the rear differential had to be rotated to reduce the angle.
- Brake pedal had to be removed and only one pedal for both rear brakes.
- Emergency brake lever and cable were moved around the transmission.
- Battery holder had to be moved to clear the lift in the drive shaft.
- Bed had to be cut and patched to make room for the battery and the parking brake cables.
