JOMA Acres Grain Facility

Andrew Sekel, Kevin Gillespie, Kyle Holt, Jonathan Everhart

Spring, 2004

- To design a grain handling facility that will meet future levels of grain production and disassemble a 70,000 bushel grain bin, which will be included in the newly designed facility.

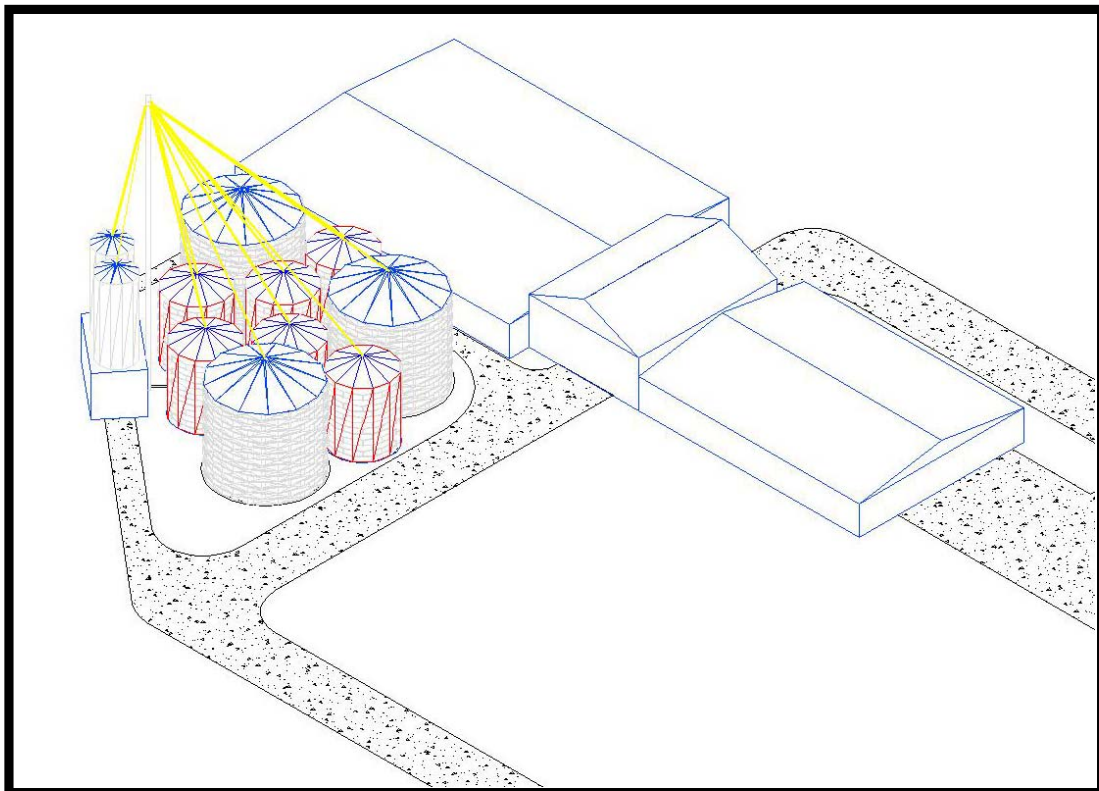
Site Layout with Grain Facility

- This draft shows the future grain facility and current buildings.
- The facility handles 300,000 bushel capacity
 - 3- 70,000 bushel bins
 - 6- 15,000 bushel bins
 - 2- 8,000 bushel holding bins
 - 20' x 40' superstructure
 - 136' 3600 bushel/hr grain leg

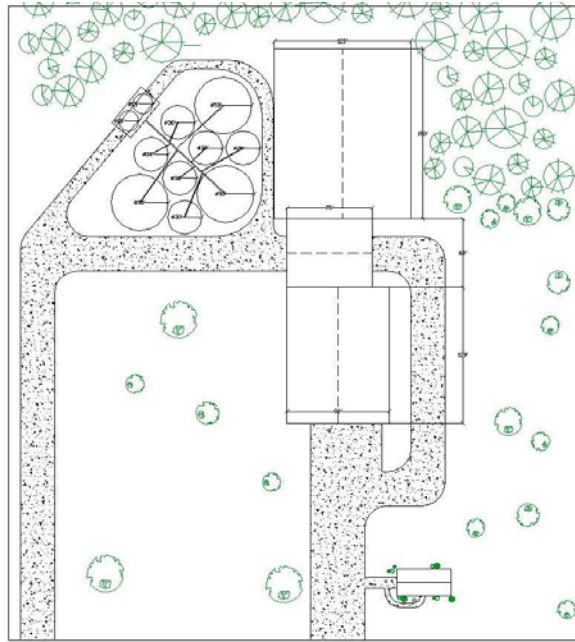
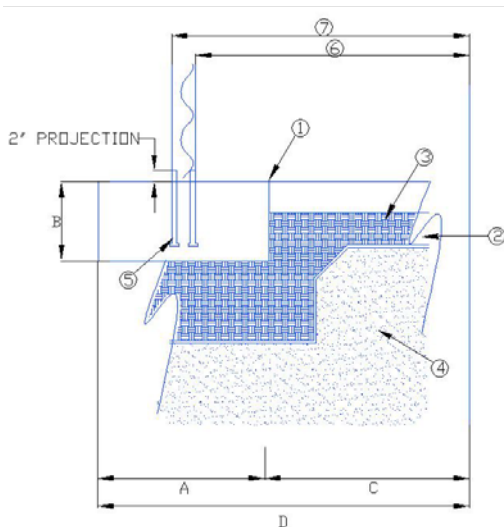
Cross-Sectional View of Foundation

- A FOOTER WIDTH 32"
- B FOOTER THICKNESS 15"
- C INSIDE FOOTER RADIUS 22'-6.5"
- D OUTSIDE FOOTER RADIUS 25'-2.5"
- 1 EXPANSION JOINT
- 2 6" BASE MATERIAL
- 3 VAPOR BARRIER
- 4 UNDISTURBED SOIL OR ENGINEERED BACKFILL
- 5 ANCHOR BOLT 5/8 X 13" HEAVY HEX HEAD ANCHOR BOLT (GRADE 5)
- 6 INSIDE STIFFENER (BOLT CIRCLE RADIUS) 23'-10.75"
- 7 OUTSIDE STIFFENER (BOLT CIRCLE RADIUS) 24'-1.25"

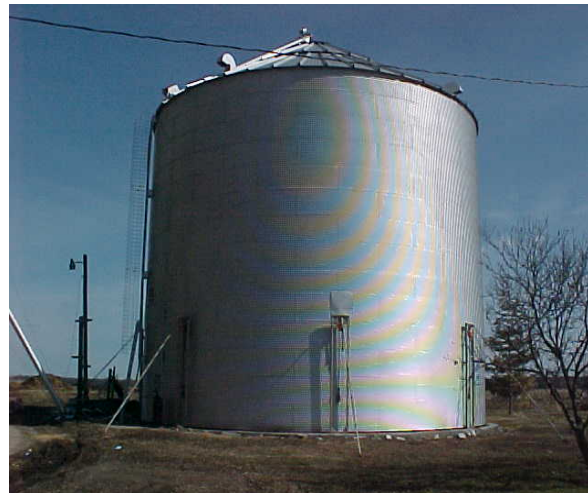
70,000 Bushel Grain Bin

- Shows grain bin fully assembled
- Grain bin is 16 rings tall
 - 43' tall on eve
 - 55' at the peak
- Grain bin has 16 panels per ring
 - Panels are 32" x 9'
 - 48' diameter
- 194 wall stiffeners inside
- Grain Bin has approximately 20,000 bolts

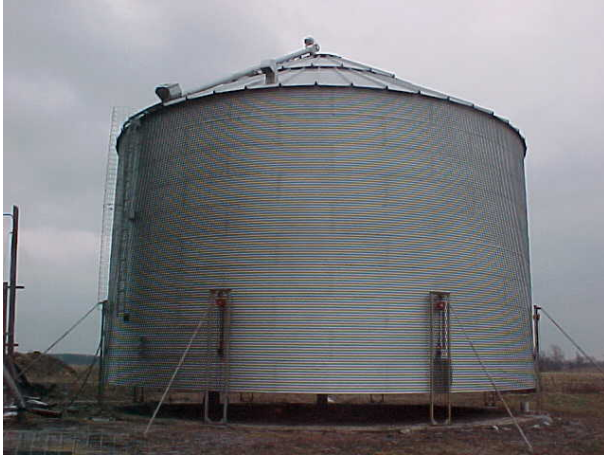
Disassembling the Grain Bin

- 8- 2 ton hoist bin jacks were used to elevate the bin
 - when raising or lowering the bin it is critical to keep them even to distribute the weight of the bin properly
- After 2 rings were taken off the brackets holding the bin had to be repositioned 2 rings higher on the bin
- Prior to rings being taken off the stiffeners had to be unfastened and removed from the inside
- All of the panels and stiffeners were numbered to their corresponding position and stacked on a trailer to be moved

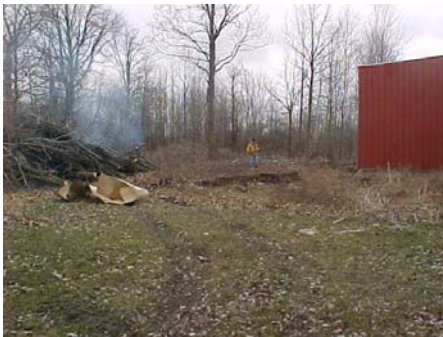
Site Preparation

- The optimum location for the grain facility was located in an area that needed to be cleared
- We cleared the trees to make it ready for aggregate to be brought in

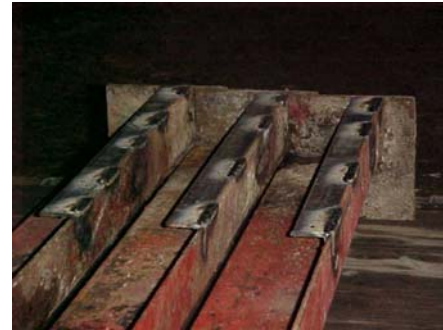
Modification of Stiffeners

- Some bottom stiffeners were bent or bowed out due to stress from the weight of the grain bin
- 1.5" x1.5" x .25" thick angle iron was welded on to the area of the stiffeners that experienced the most stress

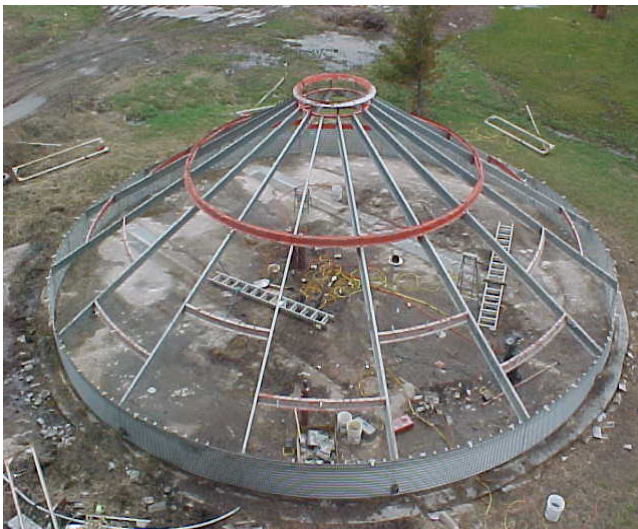
Completion of Deconstruction

- After 15 rings and the roof panels were removed the roof structure had to be disassembled
- Scaffolding was erected in the center of the bin to support the center of the structure
- Stiffeners were removed
- The z-girts were then unfastened from the top and bottom rings
- The bottom ring was then disassembled
